**Glynn Village Plat 10  
Waukee, IA 50263**

**Iowa NPDES 9433-9235**

## Notice of Potential NPDES Permit Violations

## **Site Timeline – Erosion Control Installation and Maintenance from August 16<sup>th</sup> to October 17<sup>th</sup>, 2016**

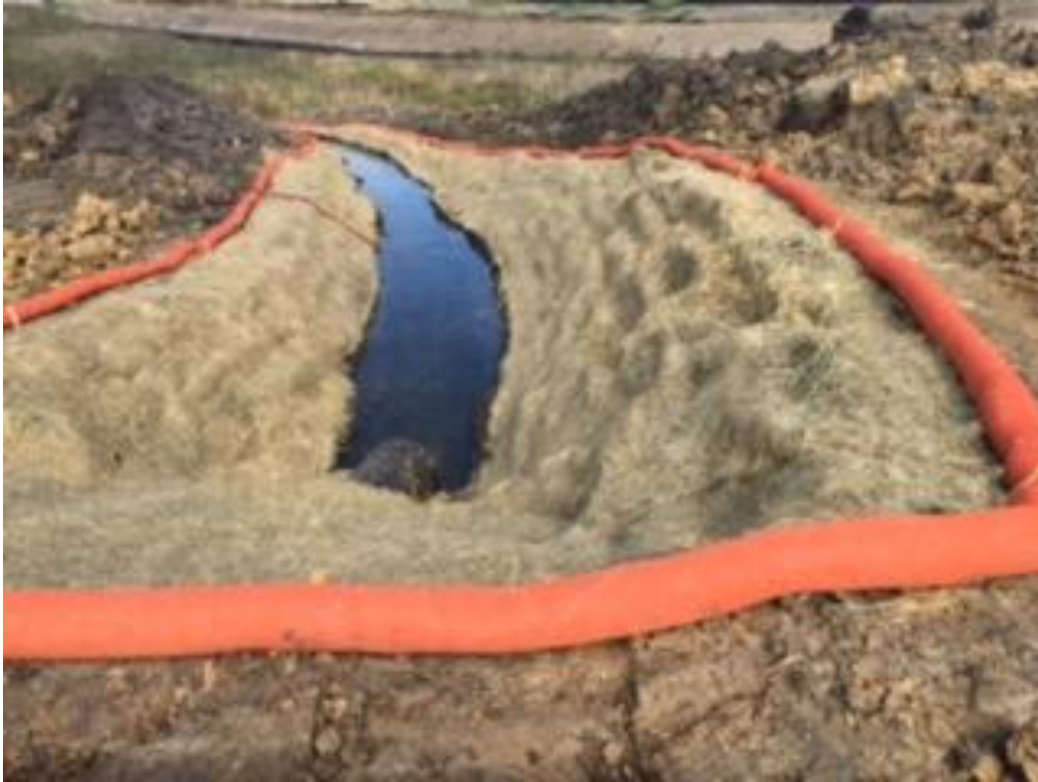
Silt Sock #60

-On 10/17/16 the slopes of the diversion trench were protected using straw matting to stop any sediment from depositing in the creek from direct rainfall and combined with a silt sock top perimeter to protect from surface flow. **See photo of "Silt Sock #60" below.**

The timeline laid out previously illustrates that controls were in place prior to the necessary construction activity needed to install the temporary culvert pipe, and that new controls were in place as soon as possible to protect the unnamed tributary.

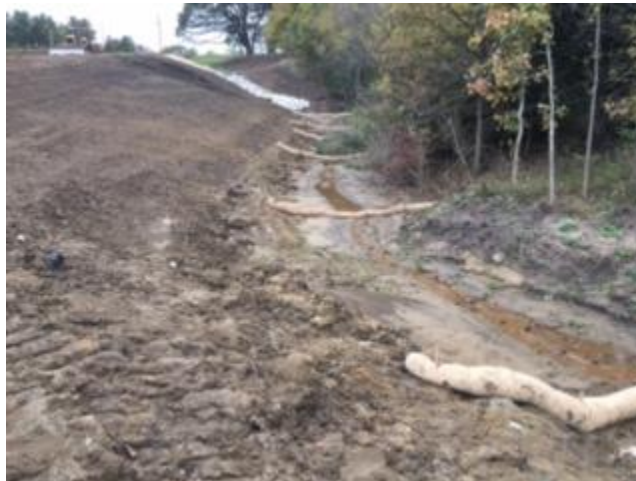
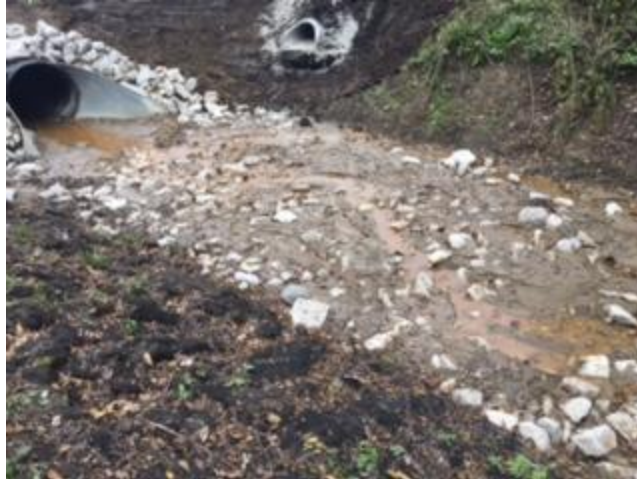
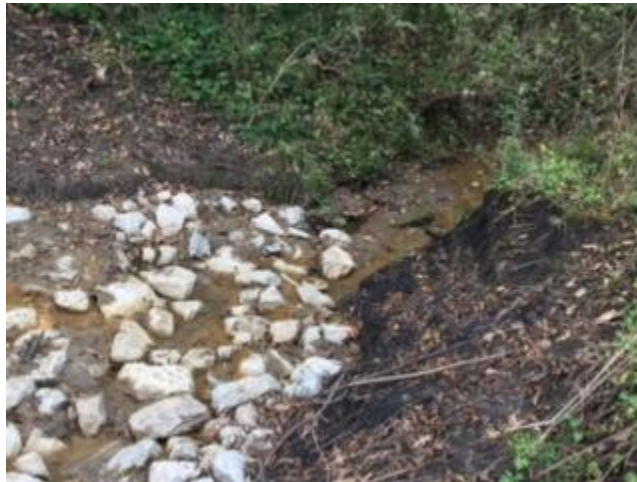
#### **City of Waukeee Storm Water Draining onto Westown Parkway Project Photos taken after 10/12/2016**

The City of Waukeee did not install controls on its slope until after the inspection date. Those controls are now in place.

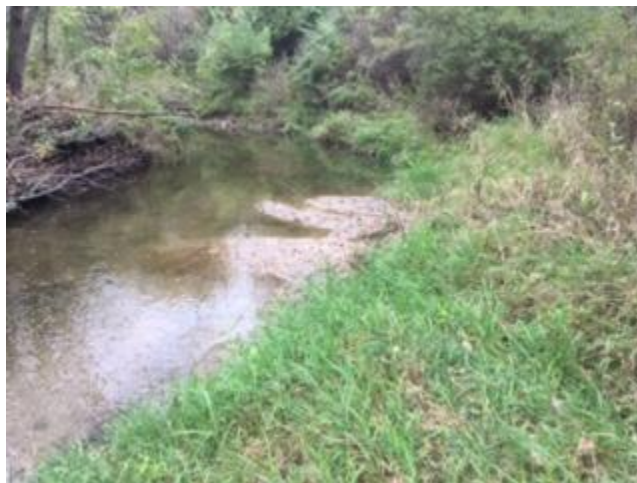
Per the inspector’s comment, runoff flowing down the unprotected steep slope belonging to the City of Waukeee caused sediment deposit. At the time of inspection, the City of Waukeee’s property (west side of Hubbell’s site) did not have controls needed to effectively slow stormwater velocity and control sediment. This lack of erosion controls allowed sediment to leave their site and deposit onto Hubbell’s site. Sediment deposited into Hubbell’s outlet structure, which flows into the unnamed tributary as seen in the pictures below. Due to the City of Waukeee’s failure to stop sediment from leaving their work site, erosion sediment collected in Hubbell’s many silt fence checks along the steep slope on the west project line, on the south side of Westown Parkway.

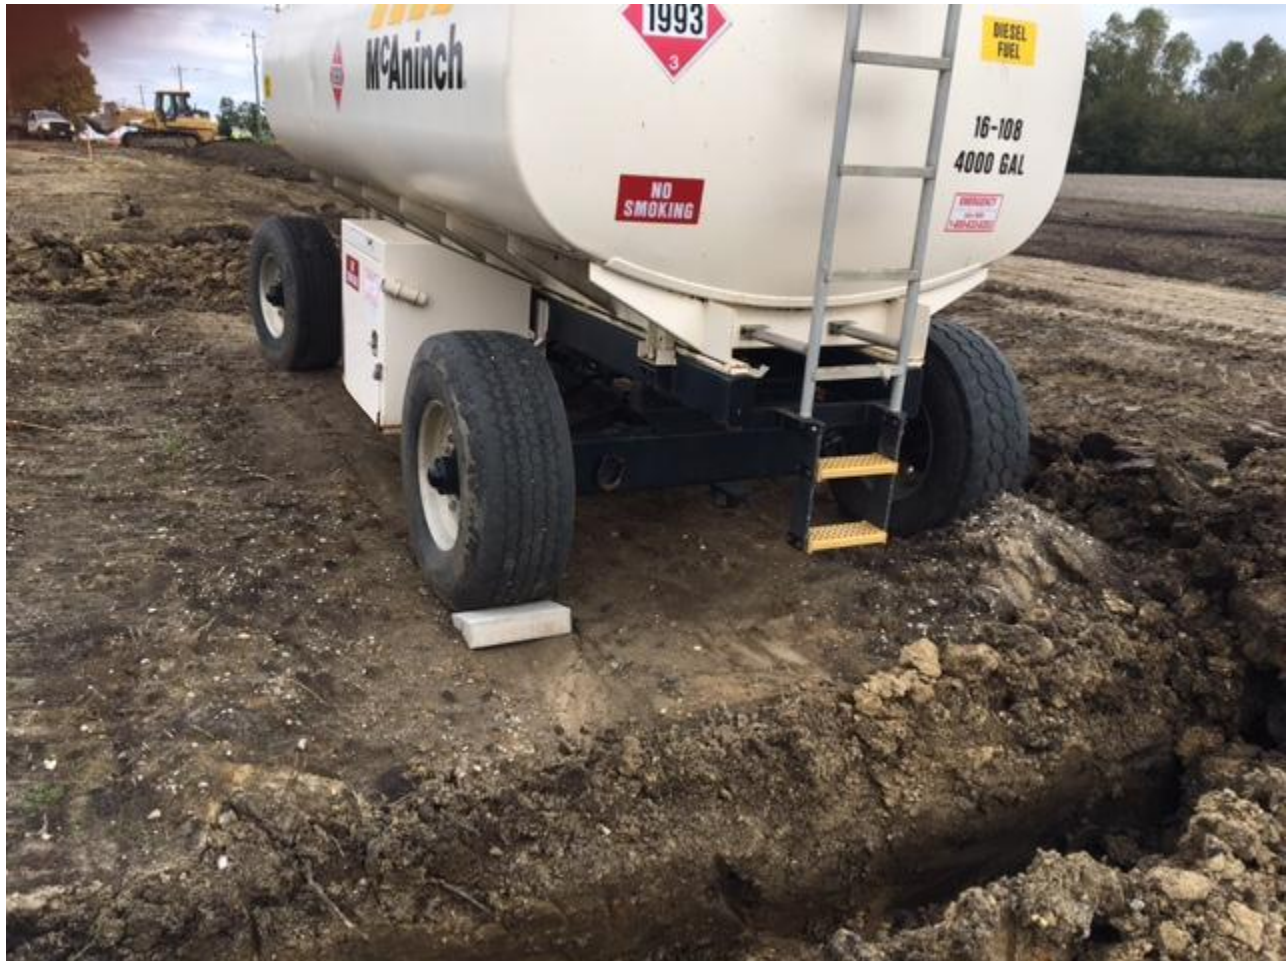
Photo of fuel tank trailer in question:

*“The Diesel Fuel tank trailer did not have secondary containment and it was parked few feet from an unprotected stormwater inlet.”*

The tank owner (McAninch) moved this tank trailer onto the site pictured on 10/06/2016. Secondary containment controls in the form of a dirt containment berm was placed around the fuel tank on 10/12/2016.

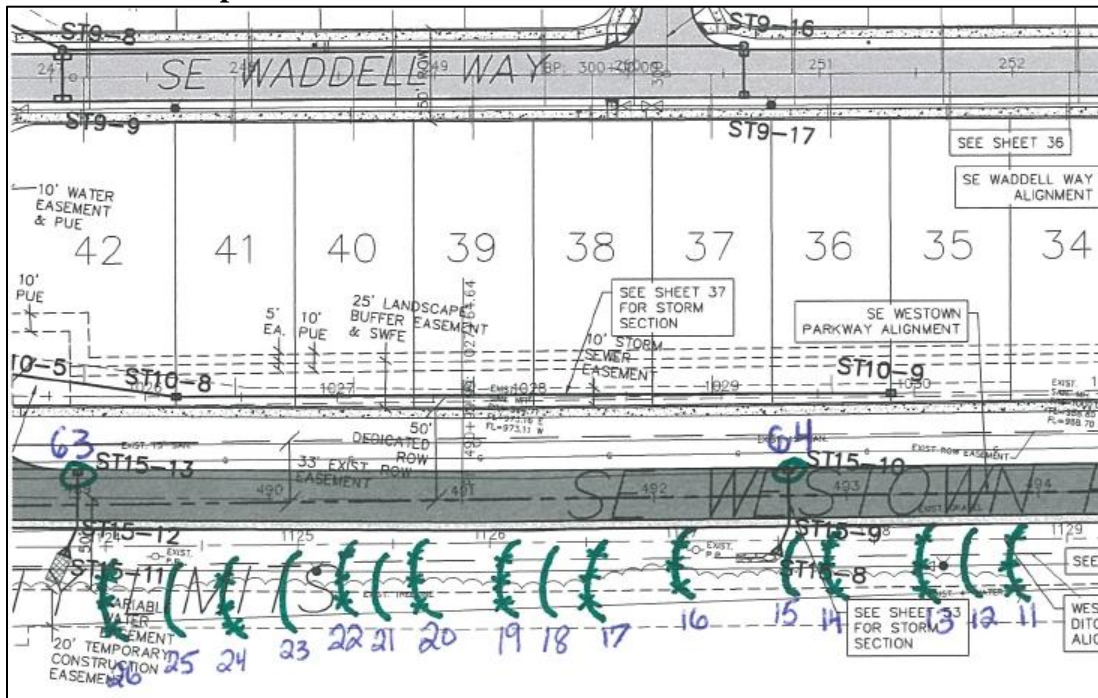
**West side of map**

**Silt Sock Numbers – 12, 15, 18, 21, 23, 25, 63, and 64. Silt Fence Numbers – 11, 13, 14, 16, 17, 19, 20, 22, 24, and 26**

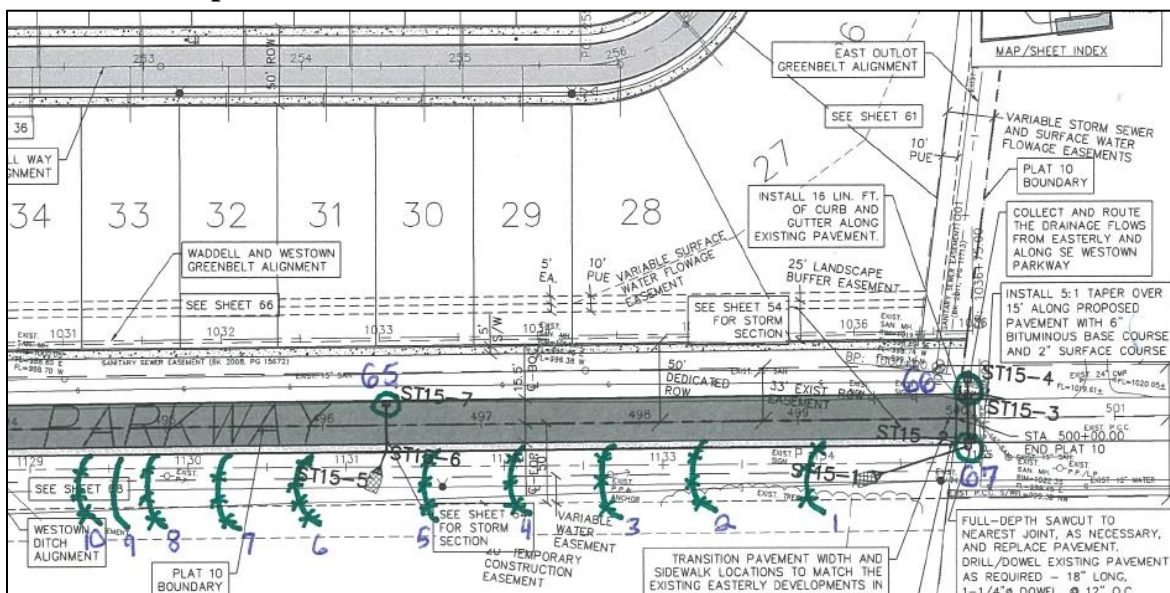
**East side of map**

**Silt Sock Numbers – 9, 66, 67**
